Florida: Crack Monitoring at a Historic Site

Campbell Scientific equipment helps to preserve and restore a historic monument

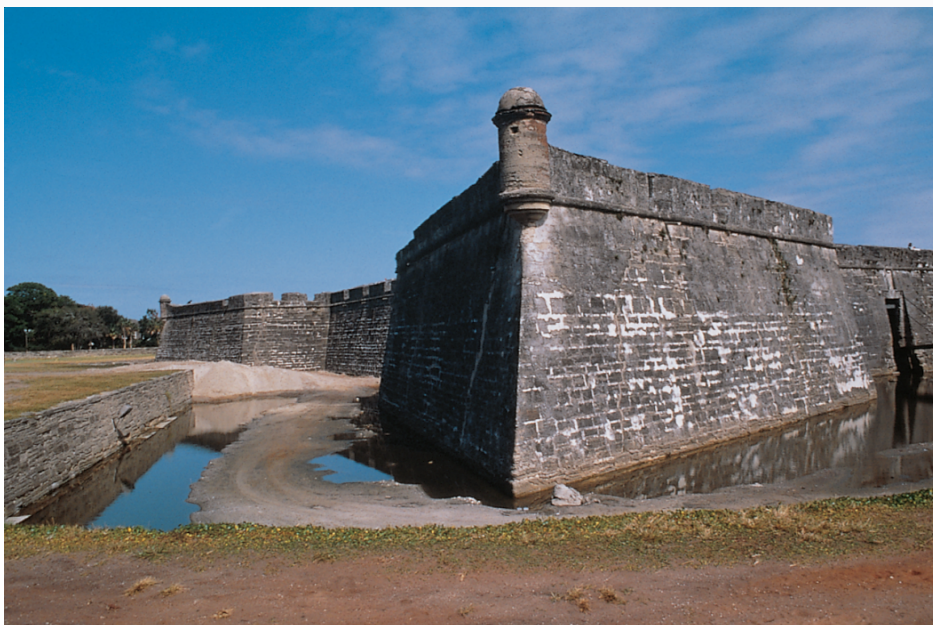
Castillo de San Marcos National Monument, St. Augustine, Florida. Taken in 1995, this view looks across the moat toward the southwest bastion, where several major cracks are visible.

The fort's bastions are earthen-filled, masonry ramparts, constructed on shallow foundations. Two of the four bastions have evidenced cracks since the early 1800s. The fort's foundations ought to be structurally sound according to an extensive investigation of both the foundations and the soil bearing capacity. An emerging theory postulates that the wall construction is near its structural limit in retaining the earth fill. Rainwater infiltration may increase the internal load on the walls, causing the structure to move. A design team was formed to investigate this theory. Headed by architects Grieves Worrall Wright & O'Hatnick, the team proposed that the park monitor:

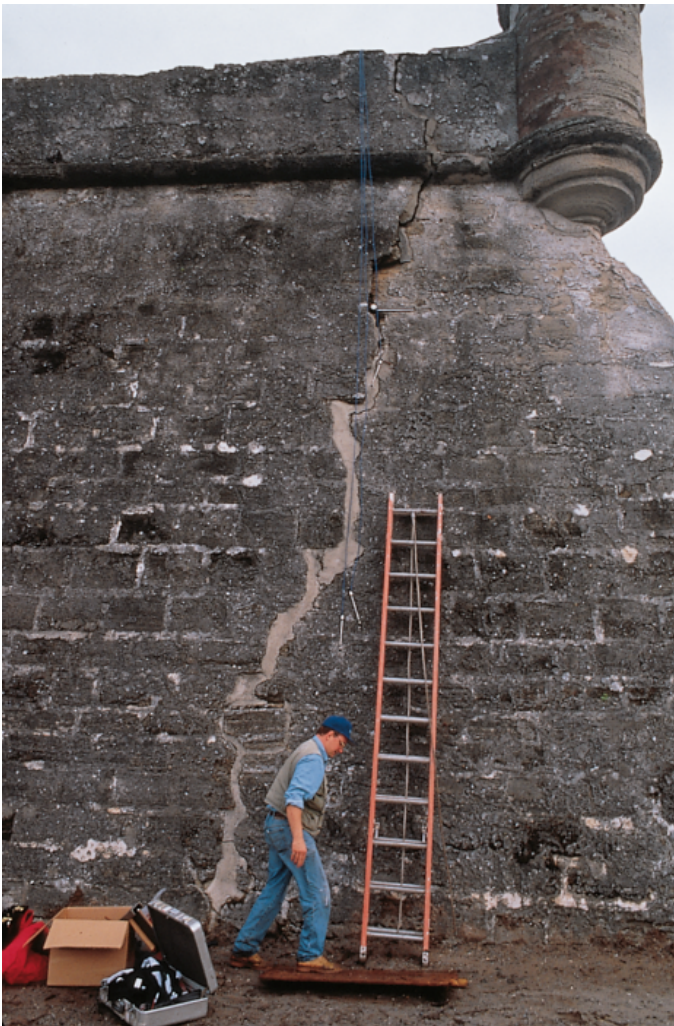
Sensors are installed across a crack in the southwest bastion.
