Wyoming: Landslide Warning

Campbell data loggers at heart of landslide warning system

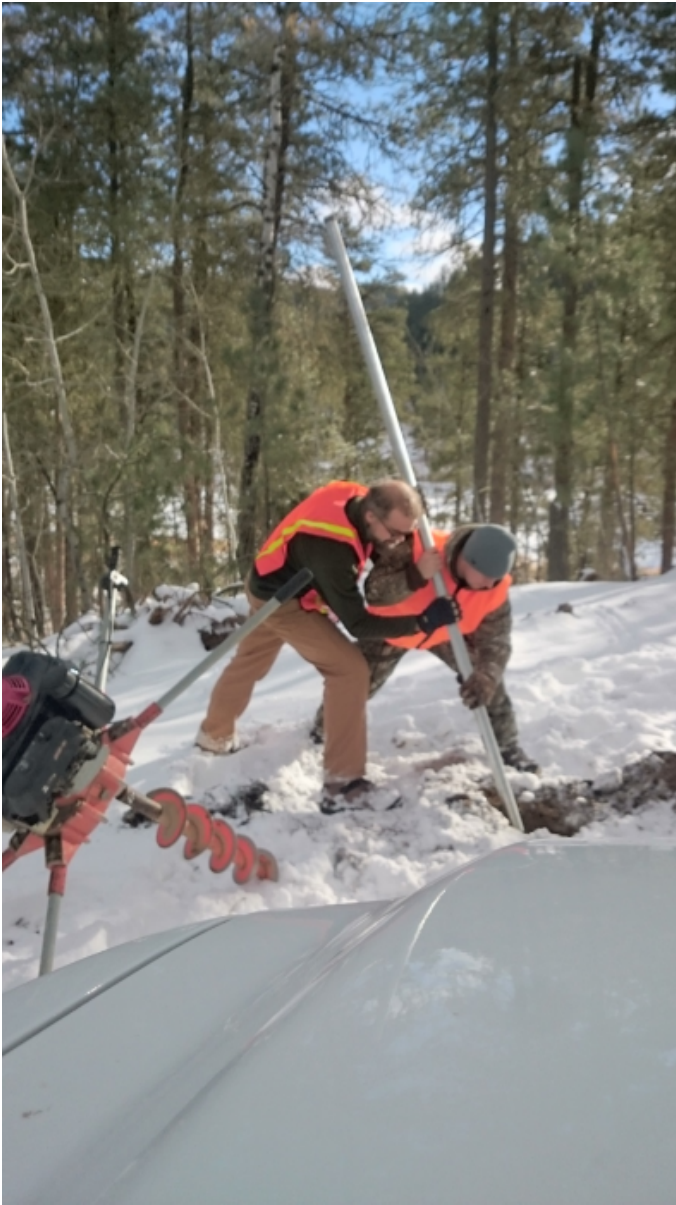
Winter installation of support structure for instrument housing and equipment

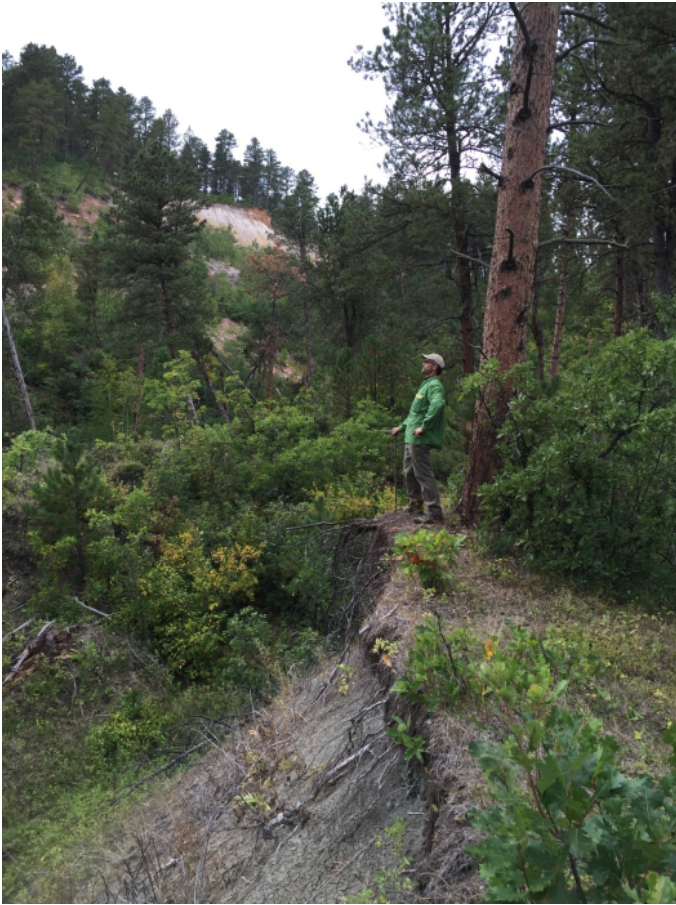
RESPEC geologist conducts reconnaissance along the landslide's inner scarp valley for drilling road access. The head scarp is visible in the background exposing mudstone of the Jurassic Morrison Formation.

In 1997, after several years of record rainfall, a large, 27-acre rotational landslide occurred at night in mudstone strata of the Jurassic Sundance and Redwater formations due to soil saturation. A near-vertical, 15-meter head scarp was formed, along with a large muddy toe from the extrusion of fluidized clay that displaced the western shoreline of the 31-acre lake. A 19-unit campground and popular hiking trail were evacuated and closed. The lake's dam was threatened with failure from overtopping, which could lead to downstream flooding and possible loss of life. The landslide remains active today, with numerous occurrences of audible tree cracks, visible rock fall, tension cracks, and a fluctuating shoreline.
