Innovative Sensor Design for Prevention of Bio-fouling

Boyd Bringhurst

Jeff Adams
Campbell Scientific, Inc.
Logan, Utah, USA
boyd@campbellsci.com

Abstract— Sensors used for in-situ water monitoring are subject to biological fouling, siltation, and scaling [3]. Fouling causes inaccurate measurements. Sensor maintenance is resource intensive. Techniques that lengthen the maintenance interval will improve measurements and conserve resources.

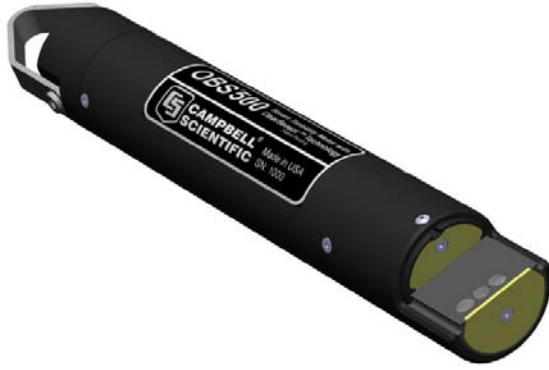
Figure 1. Prototype sensor design

A prototype optical turbidity sensor was chosen to test a new bio-resistive design as this measurement is particularly susceptible to bio-fouling. Based on the test panels and a search of the literature, a prototype was designed that incorporates new shutter and wiper designs, biocides, and removable sleeves.

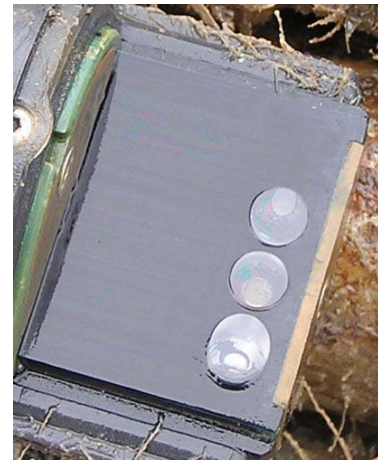
Figure 3. Wiper displaces fouling as it pushes across optics

The wiper shown in Fig. 3 is able to displace biological or other material that starts to form under a shutter [2].

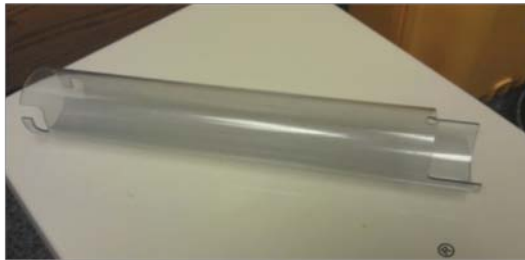
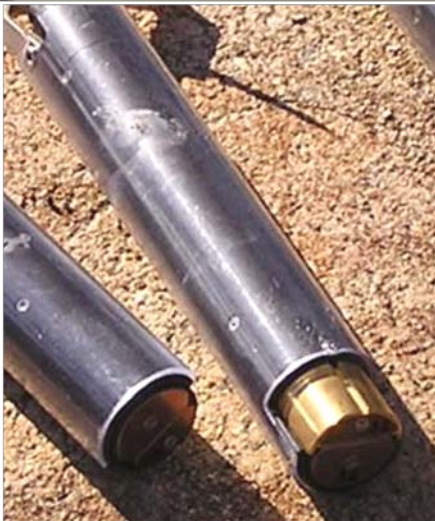
Shown in Fig. 6, easily removable disposable sleeves allow for quick cleaning of the sensor body at calibration checks. Beyond keeping the sensor optics clean, as the sensor body becomes overgrown with biological activity, the sensor is negatively influenced.

Figure 6. Plastic sleeve provides easy cleaning

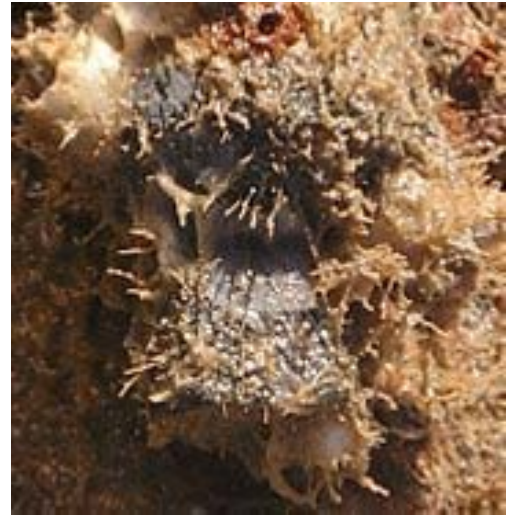
Figure 7. Baseline sensor, day 36 before cleaning

A commercially established back scatter sensor with no anti-fouling design was deployed alongside the prototype to provide a baseline comparison. The prototype received no maintenance. The baseline sensor was cleaned at regular intervals to provide data showing that cleaned baseline sensors come back into agreement with the prototype. Figs. 7 and 8 show the before and after effects of sensor cleaning.

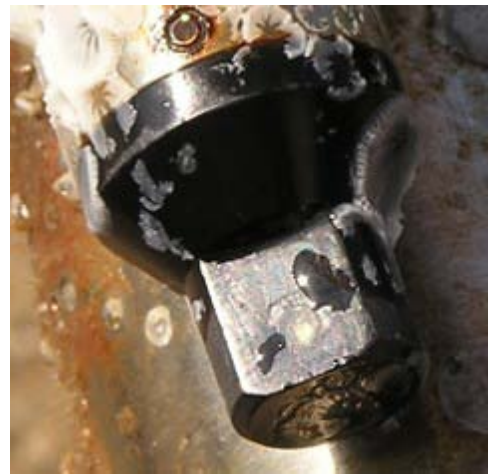
Figure 8. Baseline sensor, day 36 after manual cleaning

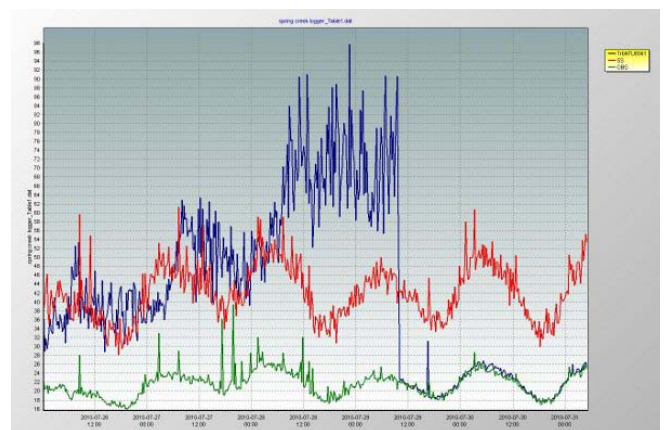
Figure 9. Baseline sensor back and side scatter

Fig. 9 shows the baseline sensor (blue) drifting higher as fouling increases. The baseline sensor was cleaned on July 29th, at which time its measurements again agreed with the measurements of the prototype sensor.

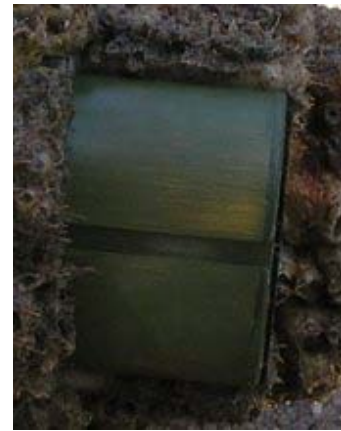
Figure 13. Day 103, shutter closed (GA)

Skidaway Island experiences a semidiurnal tide. Figs. 10 through Fig. 15 show the progression of biological growth on the prototype, but the sensing element remains free of fouling.

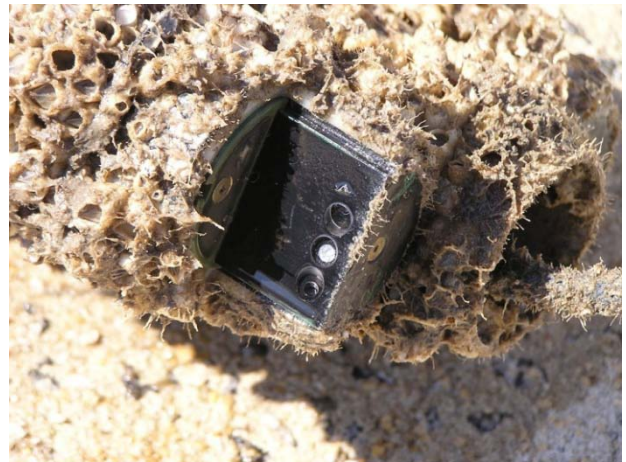
Figure 14. Day 119, shutter open (GA)

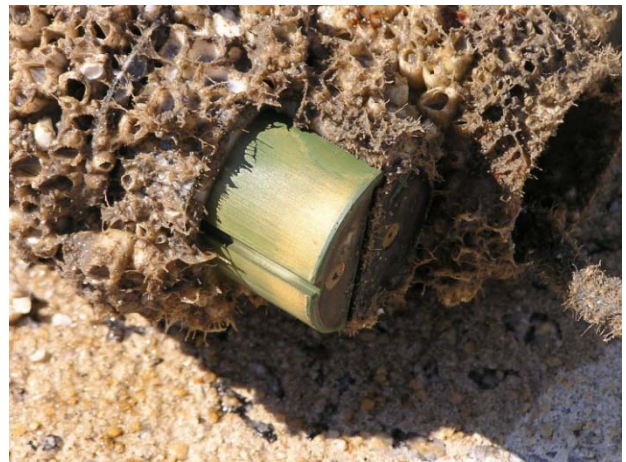
Figure 15. Day 119, shutter closed (GA)

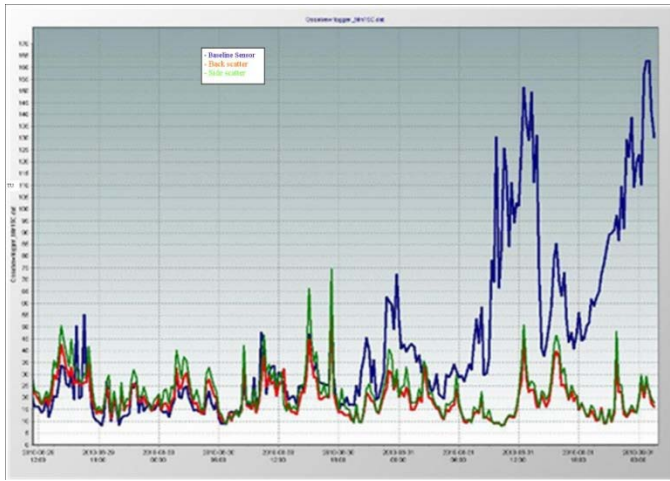
Figure 16. Effects of Bio-fouling on Backscatter Turbidity Sensors (GA)

Fig. 16 shows the baseline sensor without anti-fouling technology (blue) drifting higher after several days. After manually cleaning, the baseline sensor again tracks with the prototype sensors.

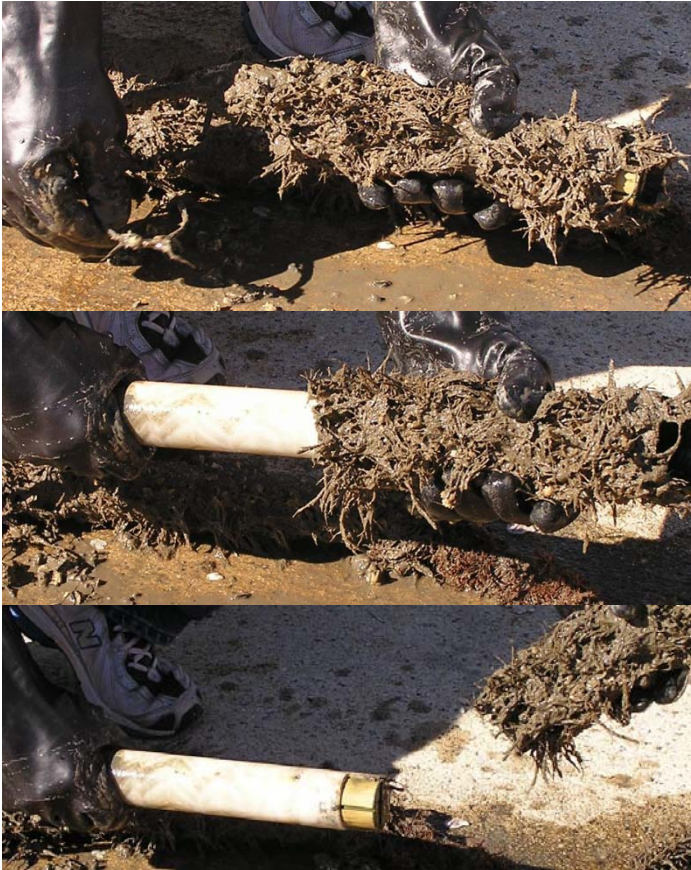
Figure 17. Process of removing a disposable plastic sleeve

Fig. 17 is a series of photos illustrating quick and easy removal of a disposable plastic sleeve at a Savannah, GA site. Where water quality measurements are made in open waters, the existence of an active biological community near the sensor has been observed to degrade measurements, even if sensor windows are clean. Keeping clean sleeves on the sensor at some regular maintenance interval will likely help measurements be more representative of the natural environment.

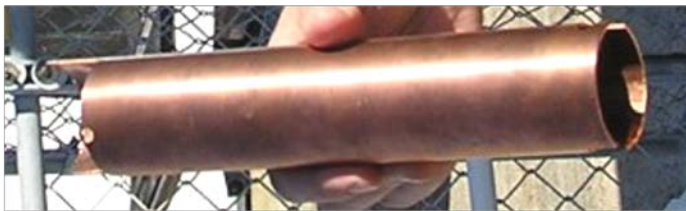
Figure 18. Removable copper sleeve

Fig. 18 shows a copper sleeve. Fig. 19 shows a copper sleeve 137 days after deployment. Fig. 20 shows significantly more biological growth on a plastic sleeve after 137 days.

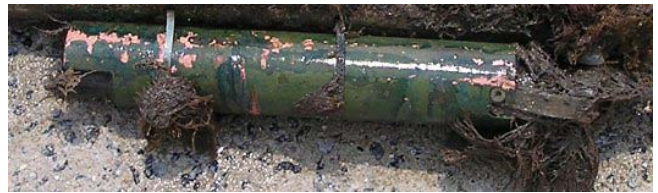
Figure 19. Copper sleeve after 137 days at Skidaway Georgia site

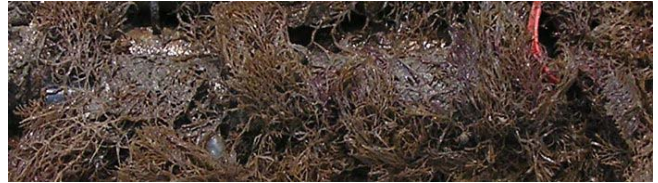
Figure 20. Plastic sleeve after 137 days at Skidaway

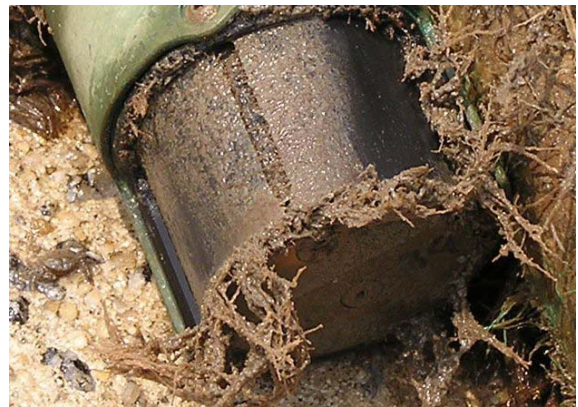
Figure 21. Delrin after 137 days at Skidaway

The Delrin shutter/wiper has growth on the tip (Fig. 21), whereas the brass remains relatively clean (Fig. 22). The growth on the Delrin shutter hung in the view of the back

scatter optics resulting in measurement error. A sensor with a brass shutter performed significantly better.

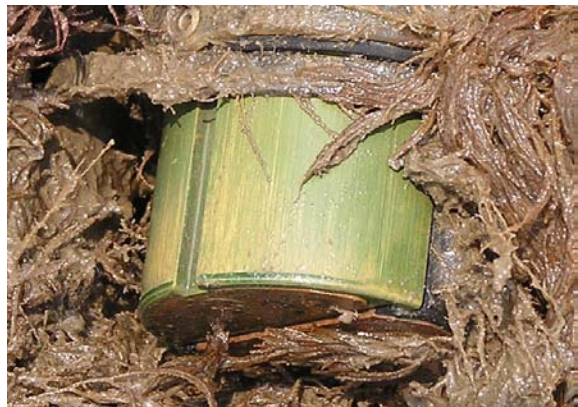
Figure 22. Brass after 137 days at Skidaway
