## Colombia: Fighting Fungus on Roses

*Campbell gear used to study conditions in rose greenhouses*

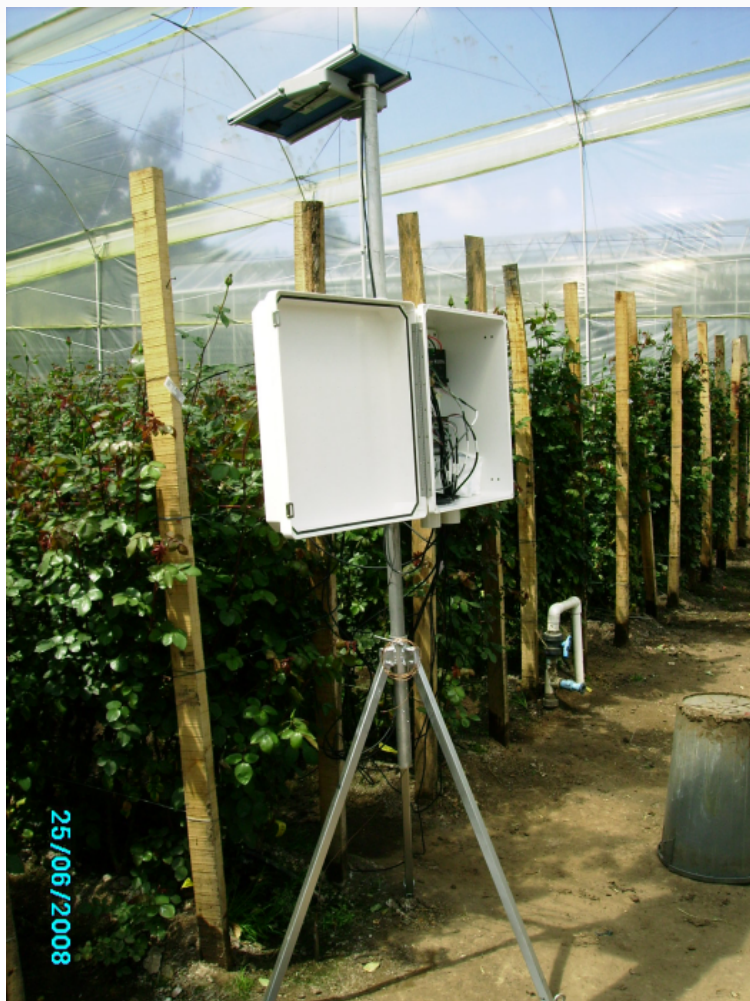
*(Photo courtesy of Francisco Gonzalez, Durespo)*

To set up the study, researchers built two measurement stations to monitor the conditions in greenhouses where roses were growing. The stations, powered by solar panels, included several Decagon LWS Leaf Wetness Sensors and Apogee SI-111 Infrared Radiometers positioned at a variety of locations among the plants. These sensors were connected to Campbell CR1000 dataloggers via our AM16/32 multiplexers. The instruments, power supplies, and enclosures all came from Campbell Scientific and were configured by Durespo, Campbell's local sales representative in Colombia.
