Connecticut: Golf Course Irrigation

Campbell ET107 Evapotranspiration Monitoring Station conserves water, improves turf

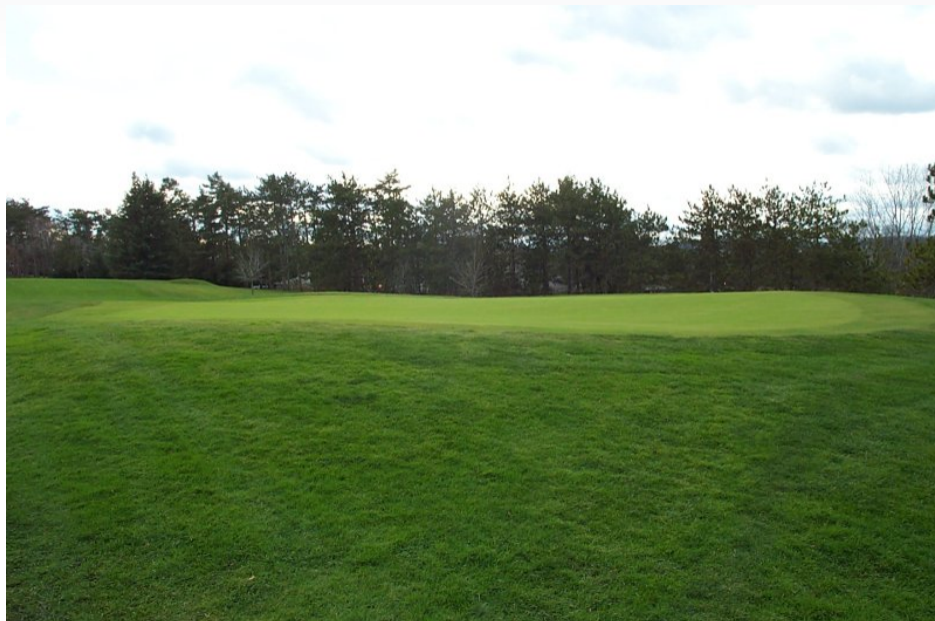
Evapotranspiration (ET) is the combination of evaporation—water movement from the surface of plants and soil—and transpiration—water movement through the plant. A weather station such as Campbell Scientific's ET107 accurately measures solar radiation, air temperature, relative humidity, and wind speed.

For the ET-based irrigation, a Rain Bird WS-PRO version of the ET107-type weather station was used for gathering the weather information for the ET calculations and to provide precipitation data that was used to stop irrigation, if needed, during a rain event.
