APPLICATION NOTE

Effects of Fouling on the Lens of OBS[®] Sensors

This application note provides information about biological and chemical fouling on the lens of OBS[®] sensors.

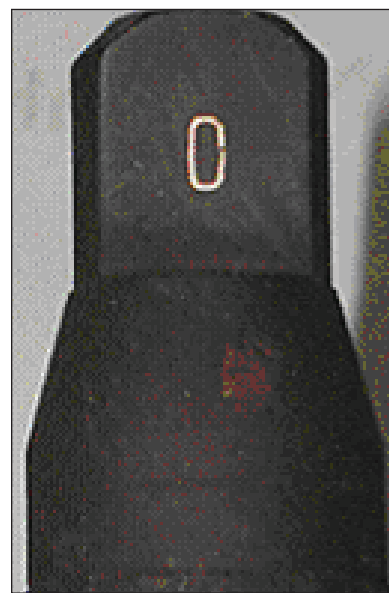
Figure 1. An OBS sensor fouled with a tannin-based film.

An example of a chemical film is shown in Figure 1. This chemical film produced the apparent decline in background turbidity shown in Figure 2. The film was a tannin-based compound common in streams and swamps.

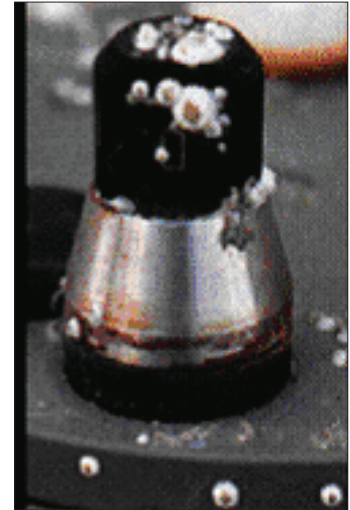
Figure 3. The barnacles on this OBS sensor produced erroneously low turbidity readings.

Barnacle growth on moored OBS sensors is very common in a shallow marine environment. Figure 3 shows barnacle growth over the infrared-emitting diode (IRED) and photodetectors of an OBS sensor moored off the California coast. The barnacles obscured the light emitter and produced declining turbidity.
